MEMOIRS OF AN AERONAUTICAL ENGINEER

**Flight Tests at Ames Research Center:
1940-1970**

Seth B. Anderson

National Aeronautics and Space Administration
Monograph in Aerospace History Series #26

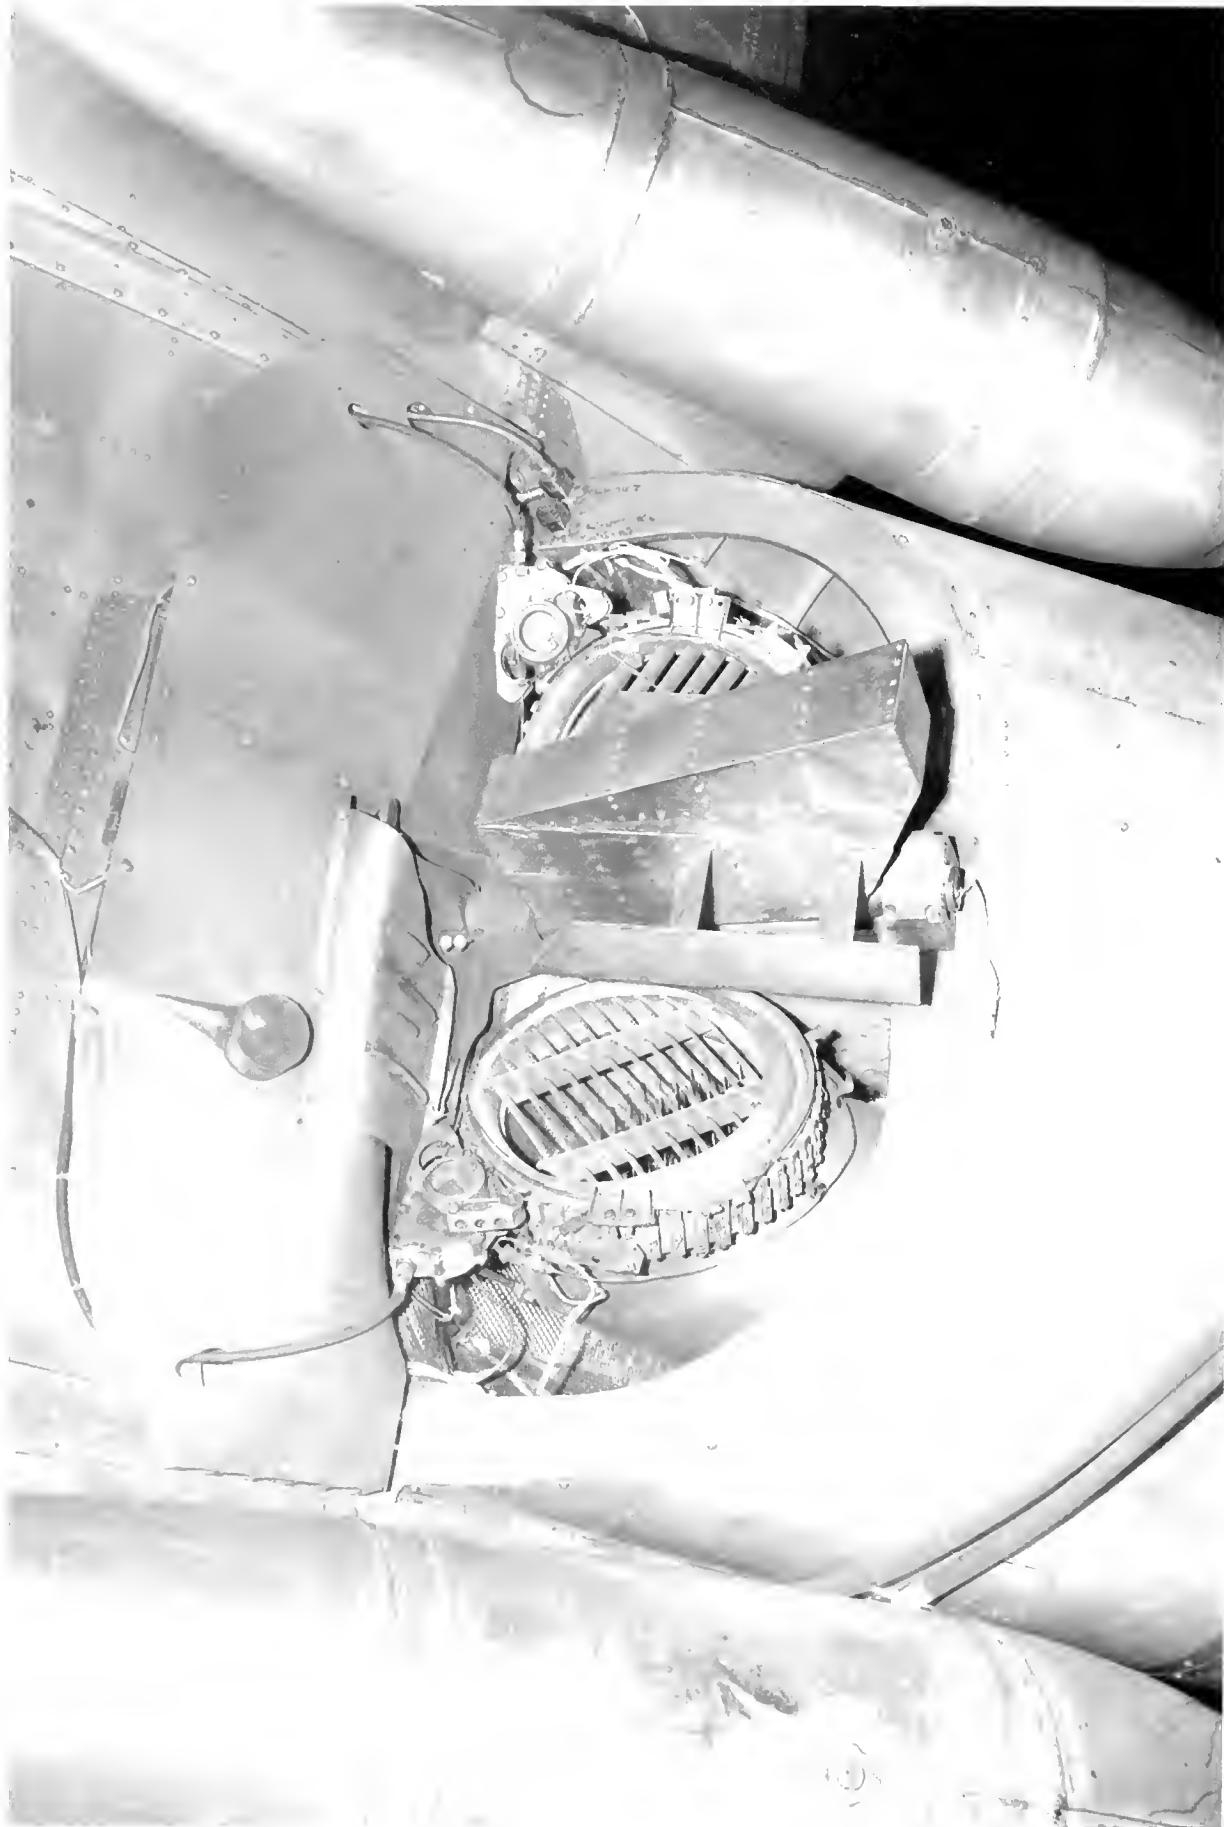
Figure 78. Cascade thrust diverters on the Bell X-14 VTOL aircraft could be rotated to deflect thrust vertically for hover or horizontally for forward cruise flight. (Jan. 1967) A-38766

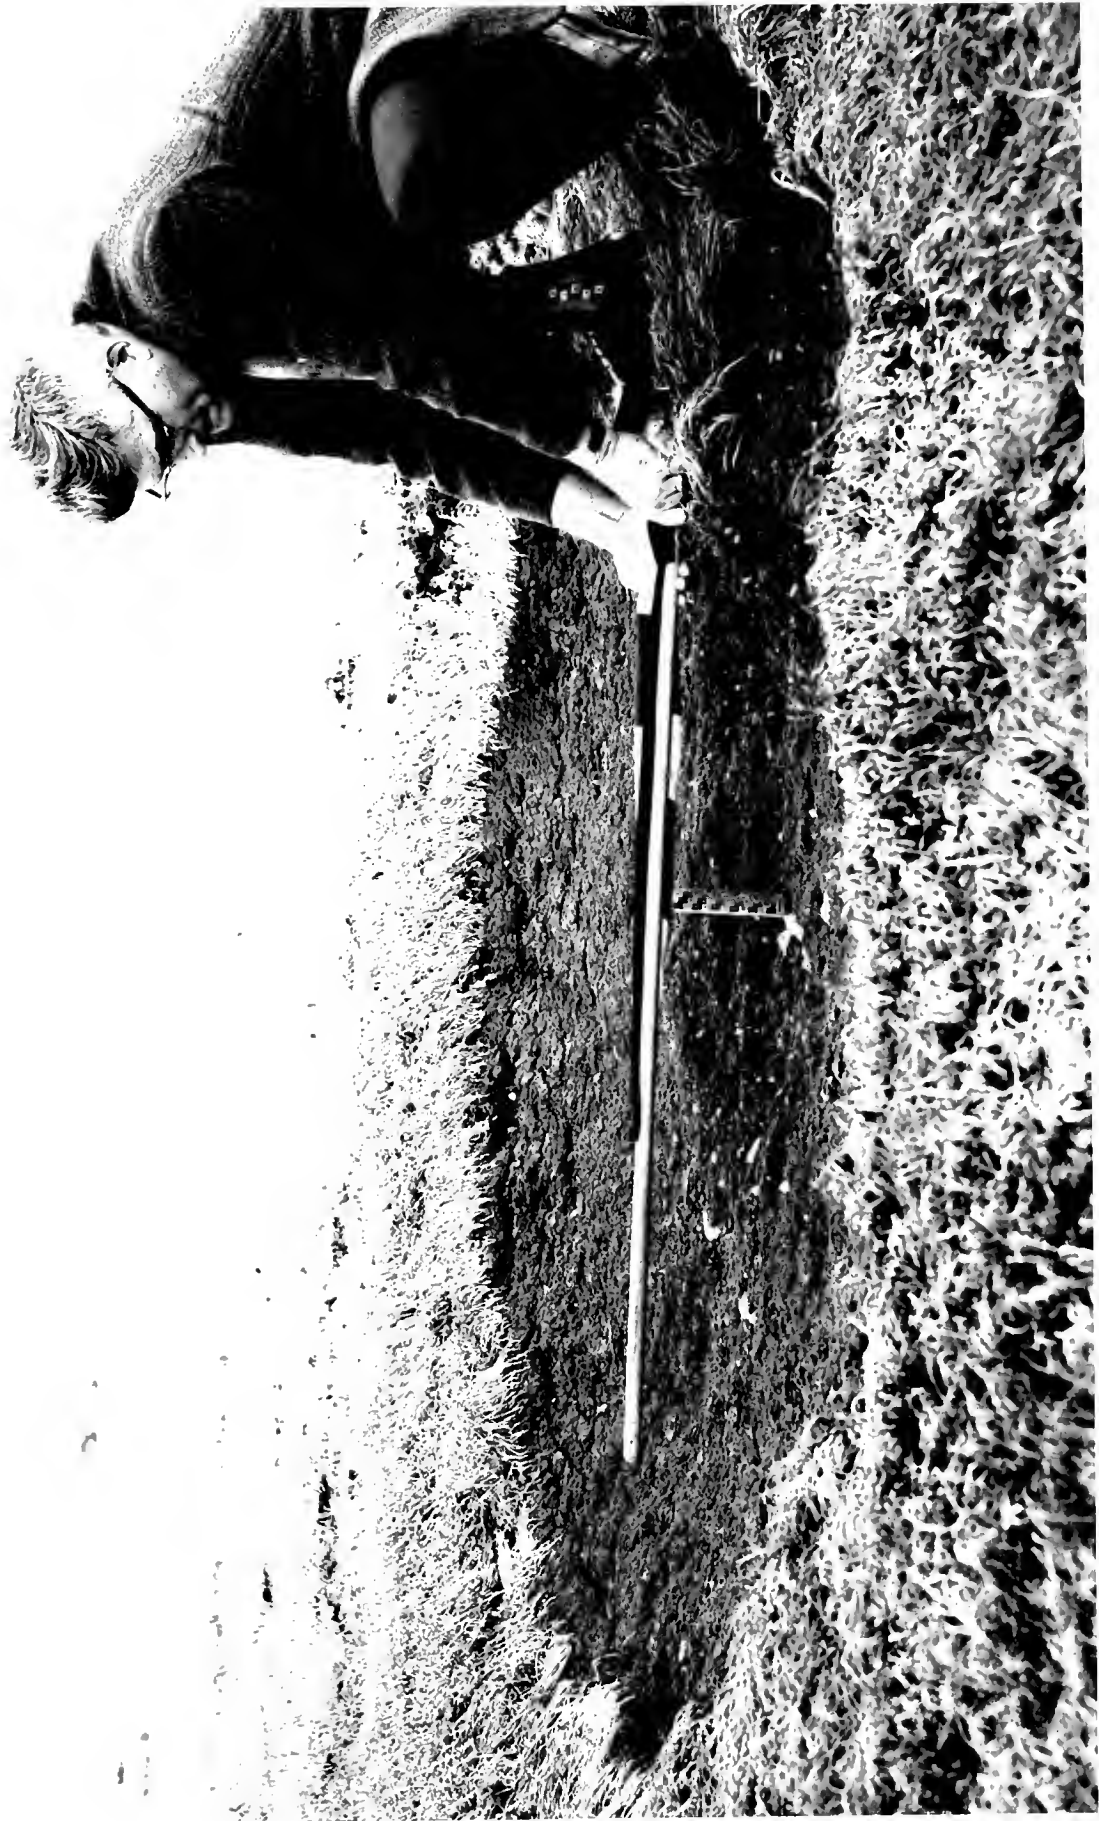
Figure 7-9. Soil erosion caused by high velocity, hot jet exhaust from General Electric F-85 jet engines on the V-14 V TOL aircraft when hovering at 6 feet. In 5 seconds, large chunks of soil were hurled upward to heights of 8 to 10 feet, forming a crater 6 feet in diameter and 6 inches deep. (May 1963) A-30386

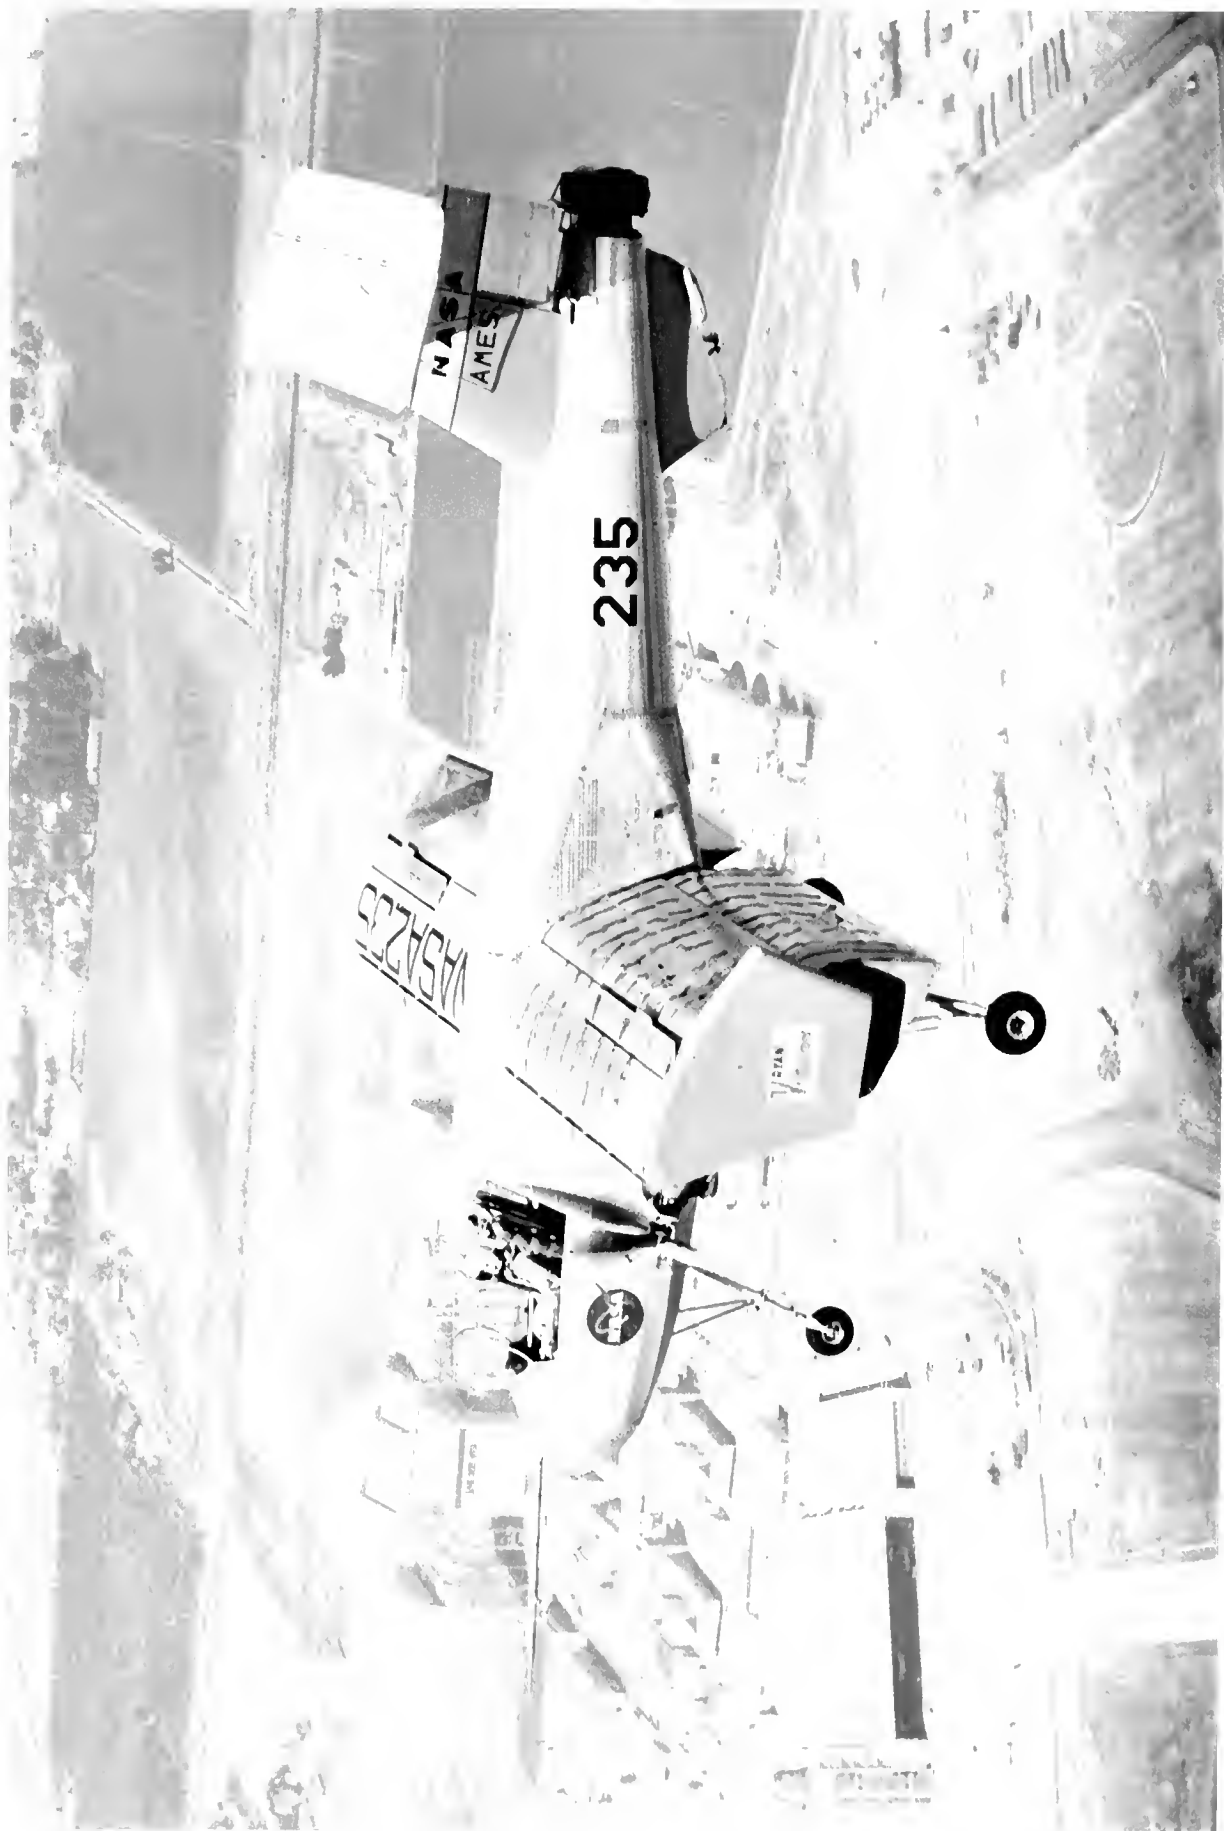
Figure 82. Ryan VZ-3RY aircraft over Ames in slow-speed flight. Smooth airflow over entire wing is indicated by tufts when wing had been modified to incorporate leading-edge slats. Tests showed that it could be flown at speeds as low as 6 knots when out of ground effect (which increases lift). (Apr. 1963) A-29657-1

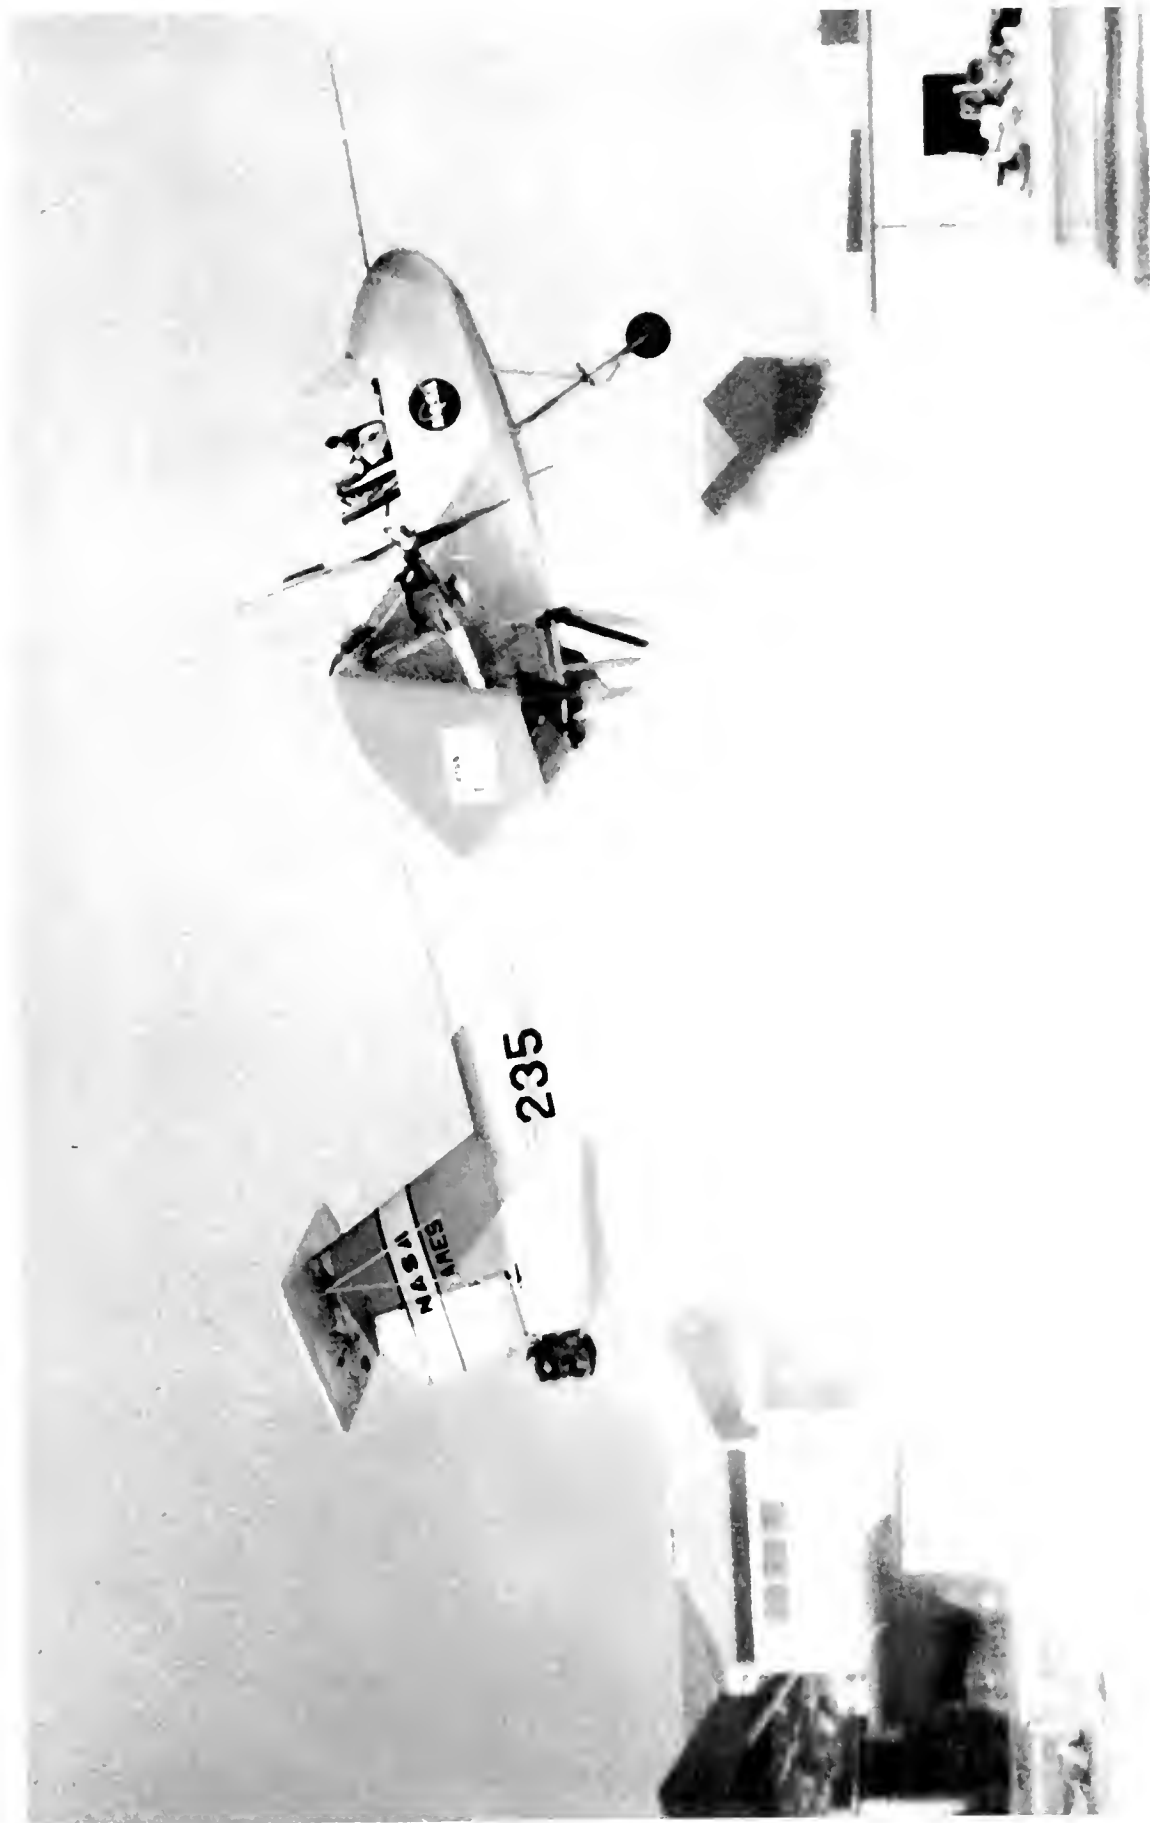
Figure 83. Recirculation of propeller slipstream of Ryan VZ-3R aircraft is indicated by smoke pattern. Recirculation caused a loss of lift and reduced lateral control at heights above the surface less than 15 feet and at airspeeds less than 20 knots. Engine exhaust vectored at rear of fuselage provided pitch and yaw control. (Apr. 1963). AC D0000193-4

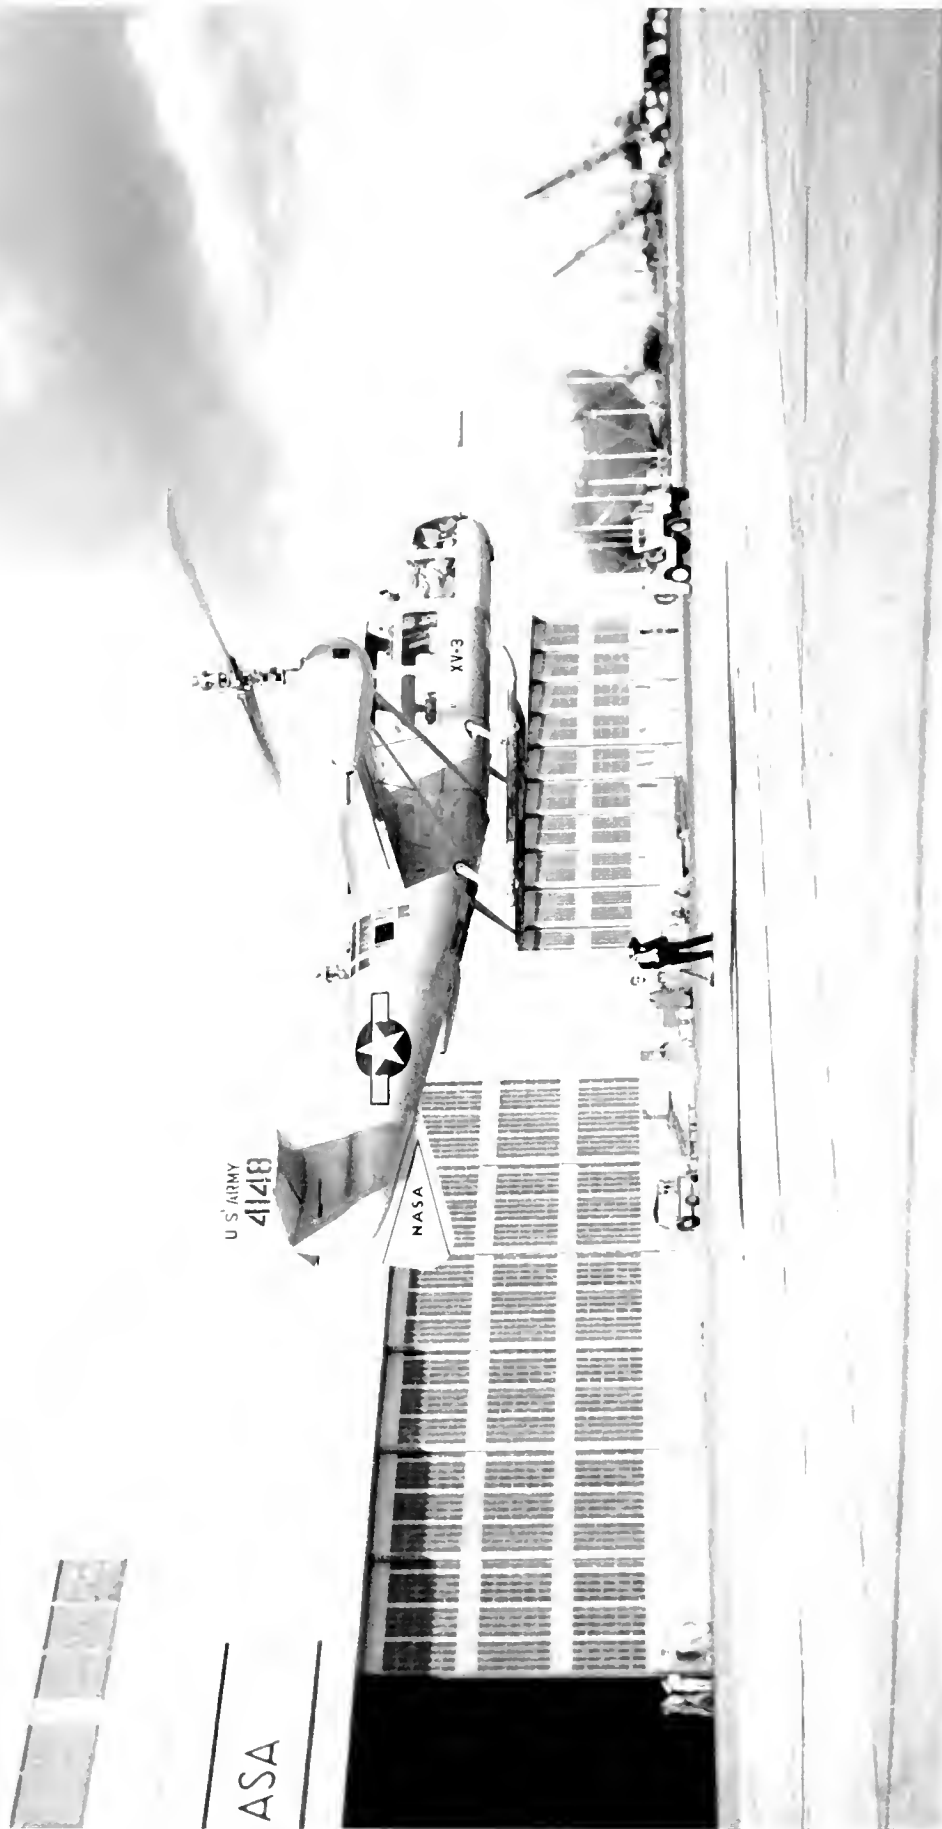
Figure 84. Bell XV-3 VTOL tilt-rotor aircraft hovering in front of building N-211 at Moffett Field. The XV-3 design combined a helicopter rotor and a wing. A 450-horsepower Pratt & Whitney piston engine drove the two rotors. The XV-3, first flown in 1955, was the first tilt rotor to achieve 100% tilting of rotors. The vehicle was underpowered, however, and could not hover out of ground effect. Note the large ventral fin, which was added to improve directional stability in cruise. (Oct. 1962) A-25685

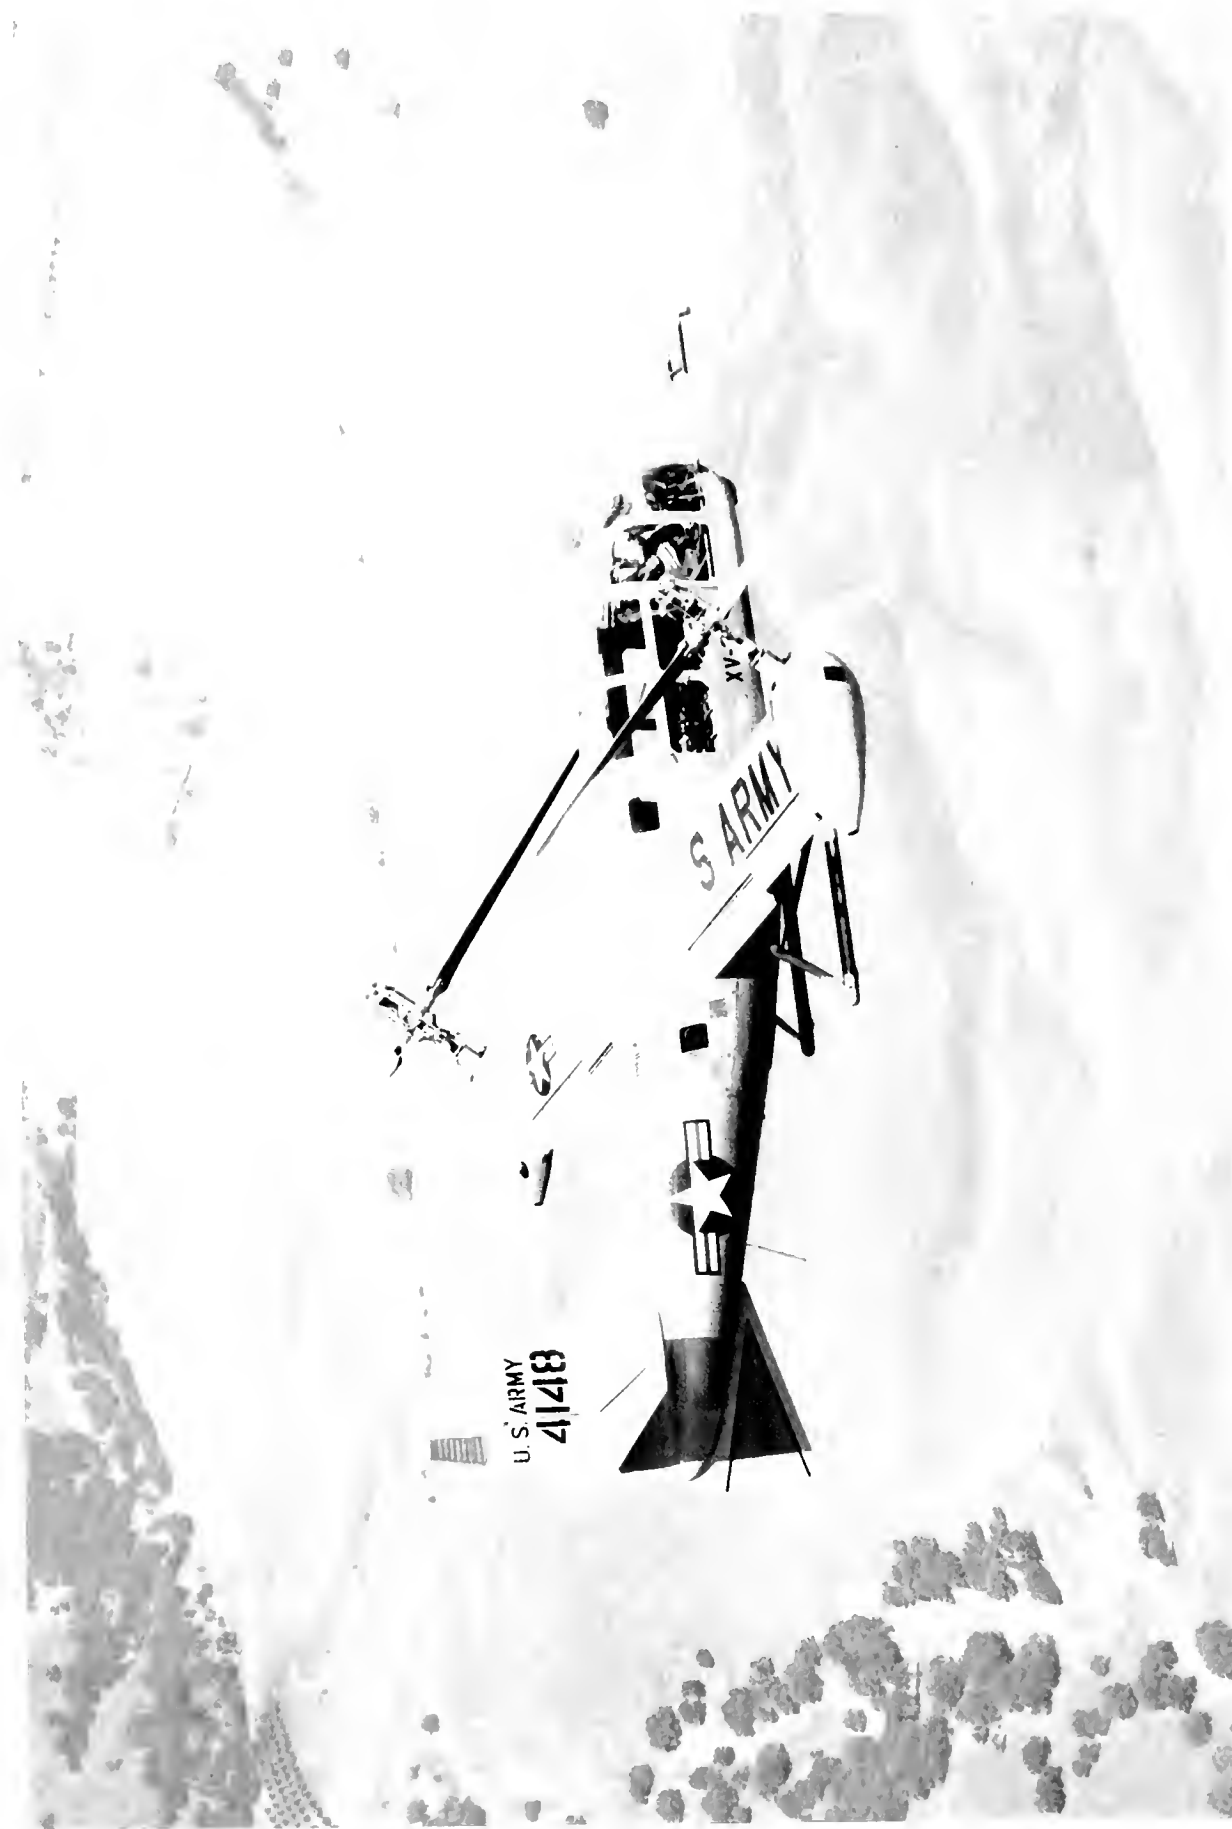
Figure 85 The Bell XV-3 rotors tilted 45 degrees, halfway through transition from rotorcraft to conventional flight. There were no trim changes or flightpath control problems during transition (Apr. 1961) A-26671

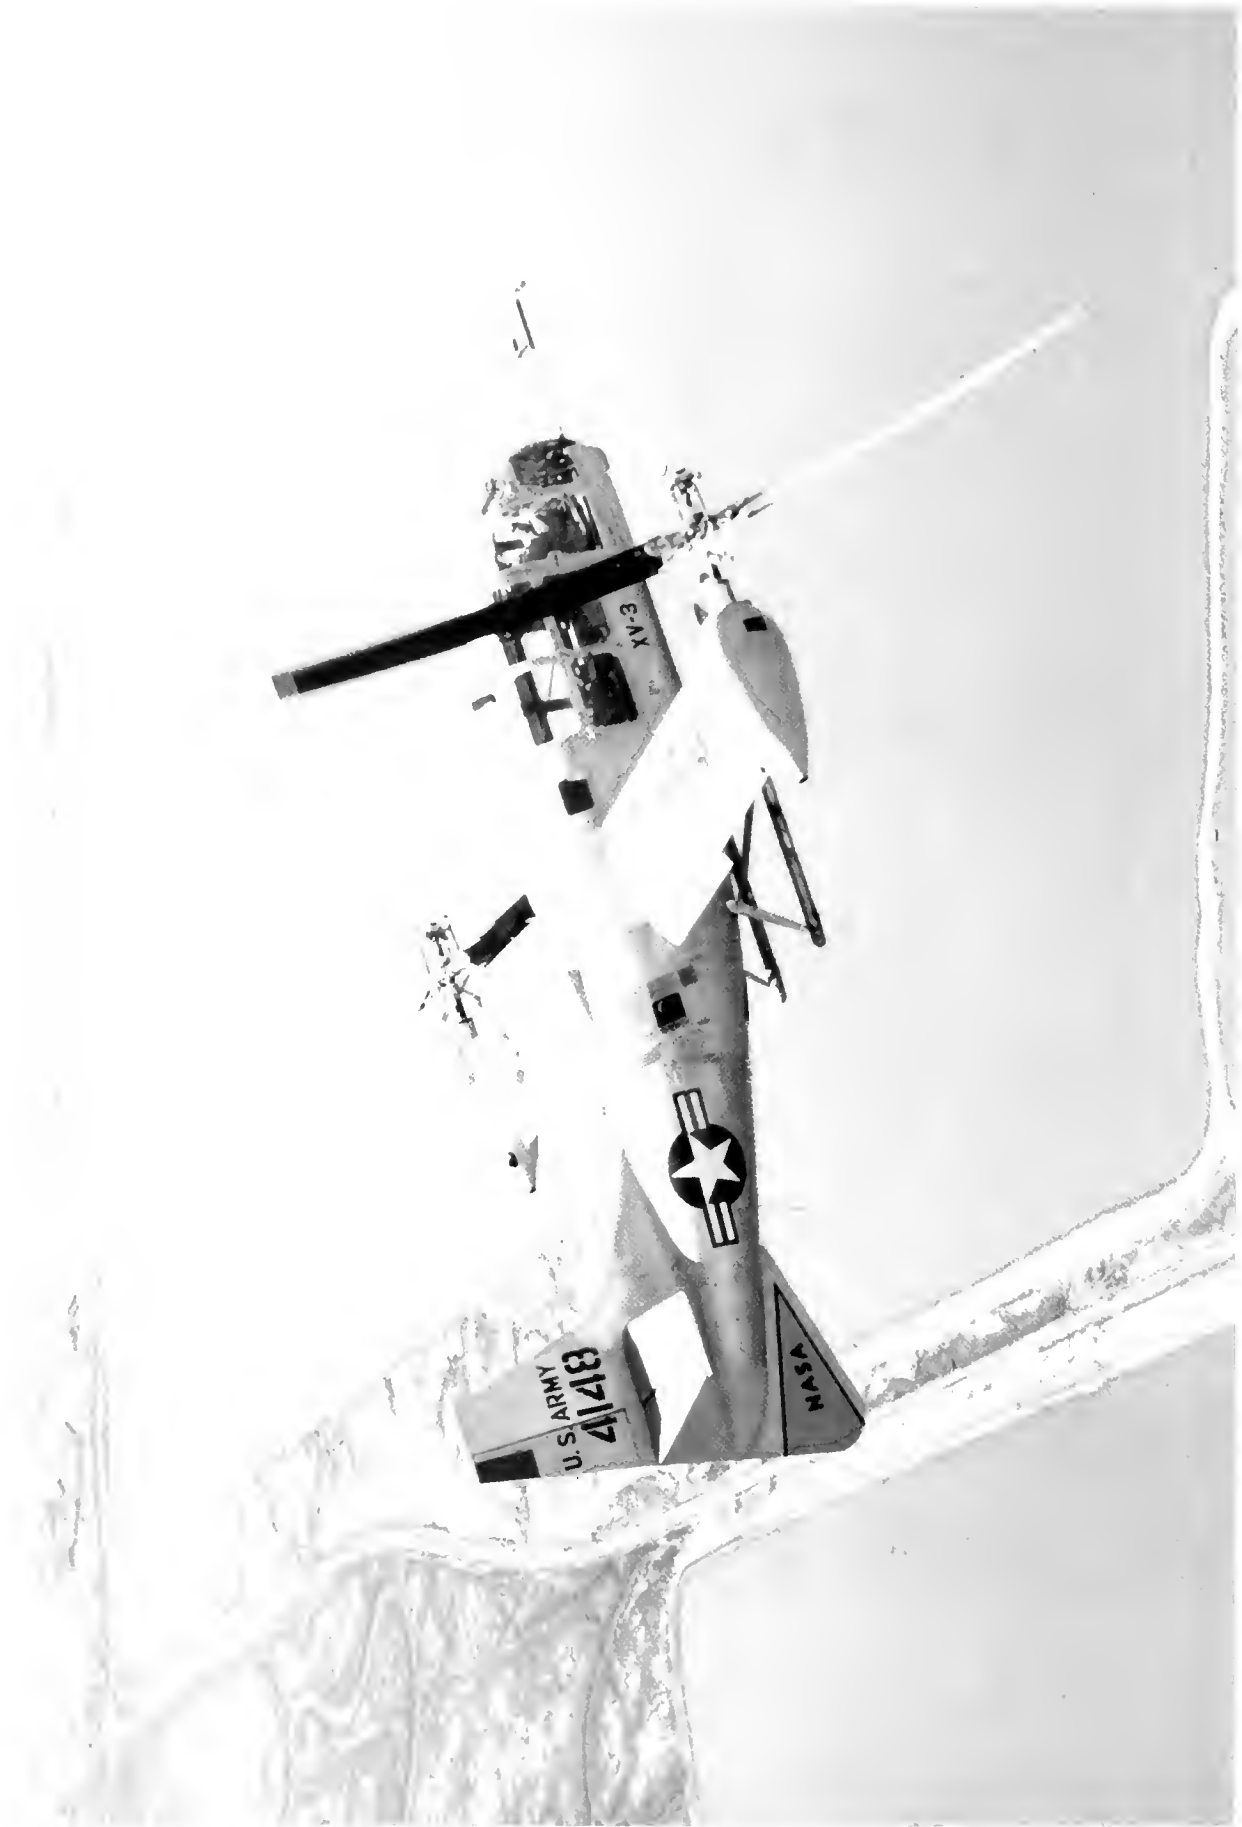
Figure 86. Bell XV-3 with rotors fully tilted for conventional cruise flight. Note large rotor-blade angle which reduced pitch and yaw static stability. Maximum cruise speed of the XV-3 was limited to 140 knots because of low damped lateral-directional oscillations. (Apr. 1961) A-2667-2
